Manhole Inspection Summary

Manhole # S51A__013MH

Insp Date: **5/6/08 7:49 AM**

Location Address: **2719 Jefferson st**

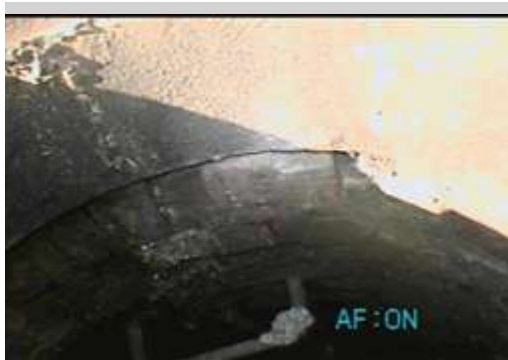
Chimney / Frame Adjustment ☒ Exists Material: **Brick and Concrete** ☐ Parged Height: **4** (in.)

frame adjustment

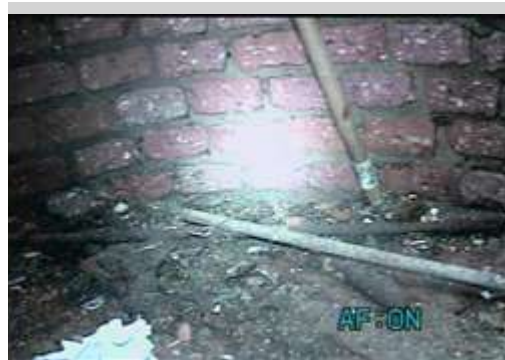
Defect 4

Condition: ☐ Sound ☐ Cracked ☐ Root Intrusion ☒ **Deteriorated** ☐ Leaks ☒ **Debris**

bench debris

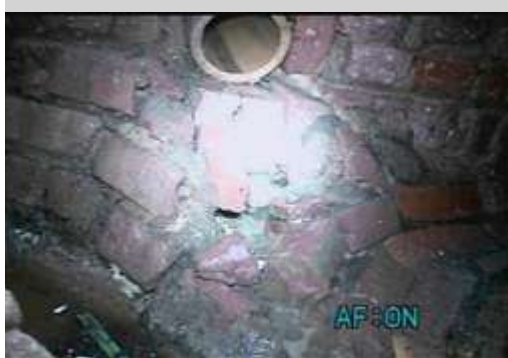
Defect 3

bench

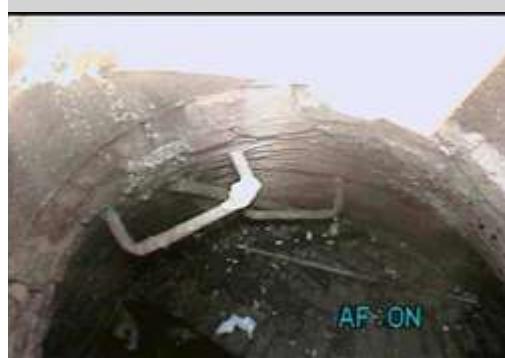
Defect 1

Steps Count: **2** Missing: **0** ☒ **Corroded**

steps

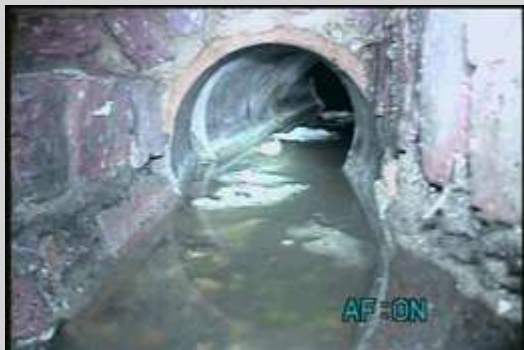
12 O'Clock Outflow

8 in. Circular Gravity Sewer
Pipe Out @ 12 O'Clock

Invert Depth: 6.17 (ft.) Flow Characteristics: **Slow**

Infiltration: **None** Pipe Seal Cond: **Unknown**

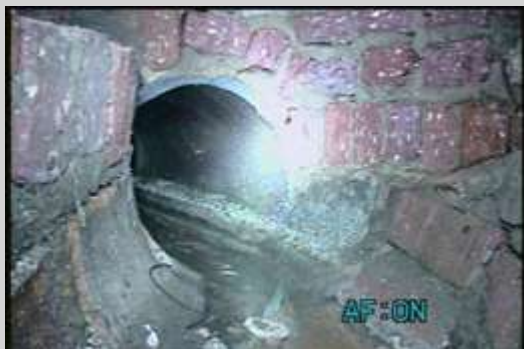
5 O'Clock Inflow

10 in. Circular Gravity Sewer
Pipe In @ 5 O'Clock

Invert Depth: 6.15 (ft.) Flow Characteristics: **Slow**

Infiltration: **None** Pipe Seal Cond: **Unknown**

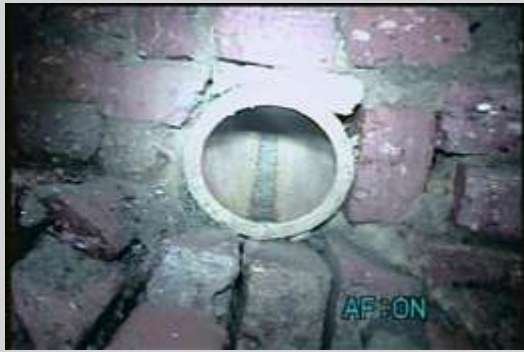
6 O'Clock Inflow

6 in. Circular Gravity Sewer
Pipe In @ 6 O'Clock

Invert Depth: **5.05** (ft.) Flow Characteristics: **Slow**

Infiltration: **None**

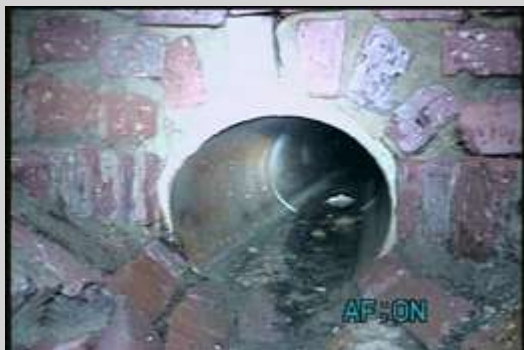
9 O'Clock Inflow

8 in. Circular Gravity Sewer
Pipe In @ 9 O'Clock

Invert Depth: **6.06** (ft.) Flow Characteristics: **Slow**

Infiltration: **None**
